**A Chemical Water Quality Analysis of the
Eightmile River, West Branch**

A Thesis

Master of Arts in Biological Sciences: Ecology and Environmental Sciences

Central Connecticut State University

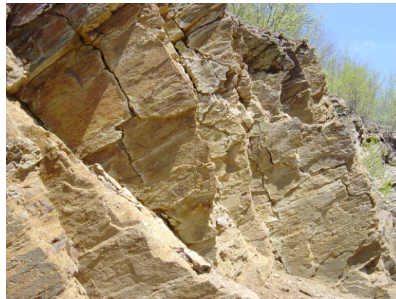
Figure 1. Glacial till

The bedrock of the watershed is composed of metamorphic schist and gneiss (Rodgers 1985, Albeitz and Pokhrel 2004, CT DEP 2005a, b). The watershed contains twelve main types of bedrock (Rodgers 1985, CT DEP 2005a, b) (Appendix B). Outcrops in the area contain glacial till (Figure 1) overlying bedrock (Figure 2).

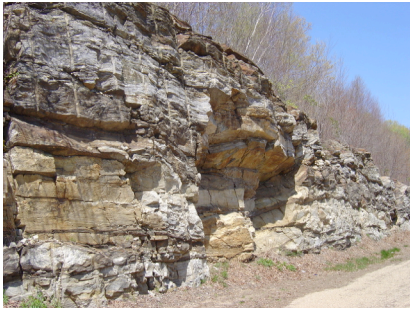
Figure 2. Layering

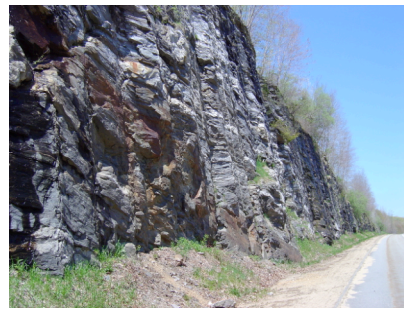
Figure 3. Fracture flow

Ground water flow occurs mainly through fractures (Figure 3) in these areas.

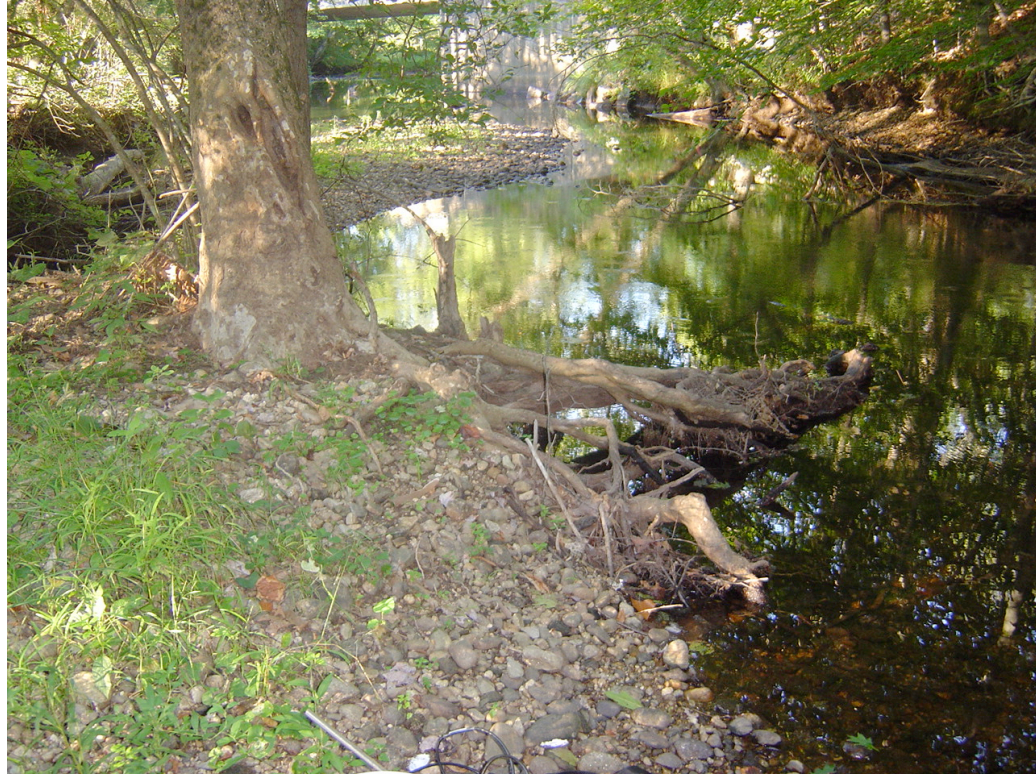
Figure 5. Site 1 collection location

Site 1 (Figure 5) is located on the West Branch of the Eightmile River at Route 156 in Lyme, Connecticut. This collection site is on the main stem of the Eightmile River. It is the closest collection site to the junction with the Connecticut River. This section of the river is classified as stream order five (CT River Coastal Conservation District 2004). Due to its high order, the River Continuum Concept indicates that primary production here will be primarily comprised of algae and rooted plants, community respiration occurs, and primary productivity could be limited by depth and turbidity (Vannote *et al.* 1980).

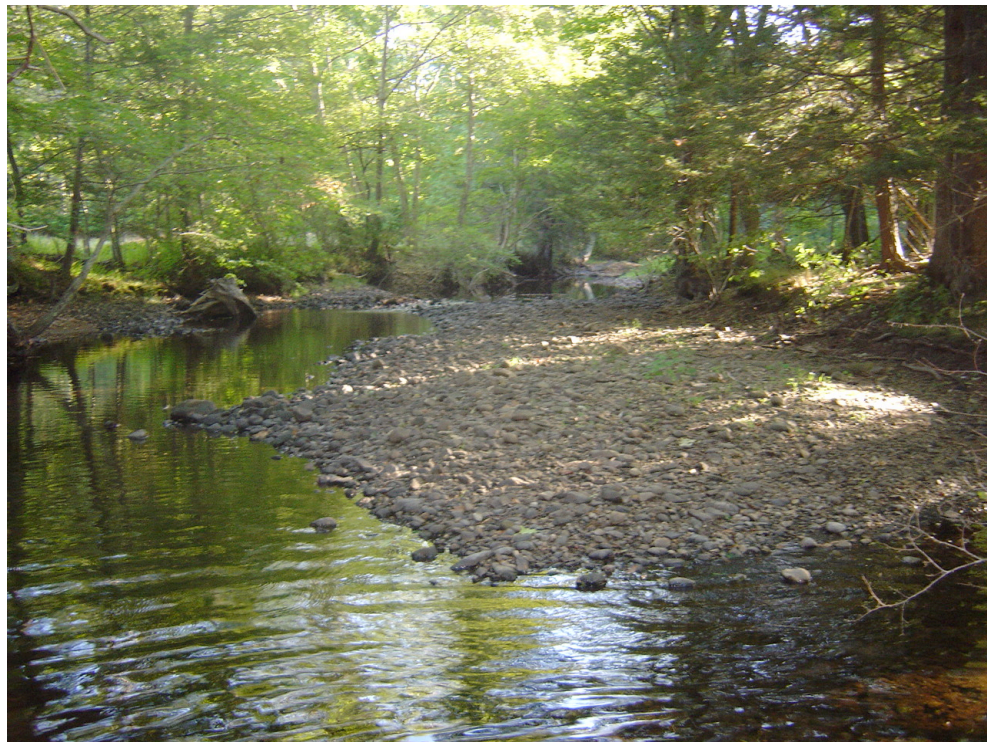
Figure 6. View upstream at Site 1

The area is covered with smooth, fist-sized, round cobbles that are present upstream and downstream of the collection area. Upstream (Figure 6) is an area of greater depth and pooling where the flow slows considerably and settling occurs. Animal life such as beavers and an abundance of fish were observed here. While no mussels

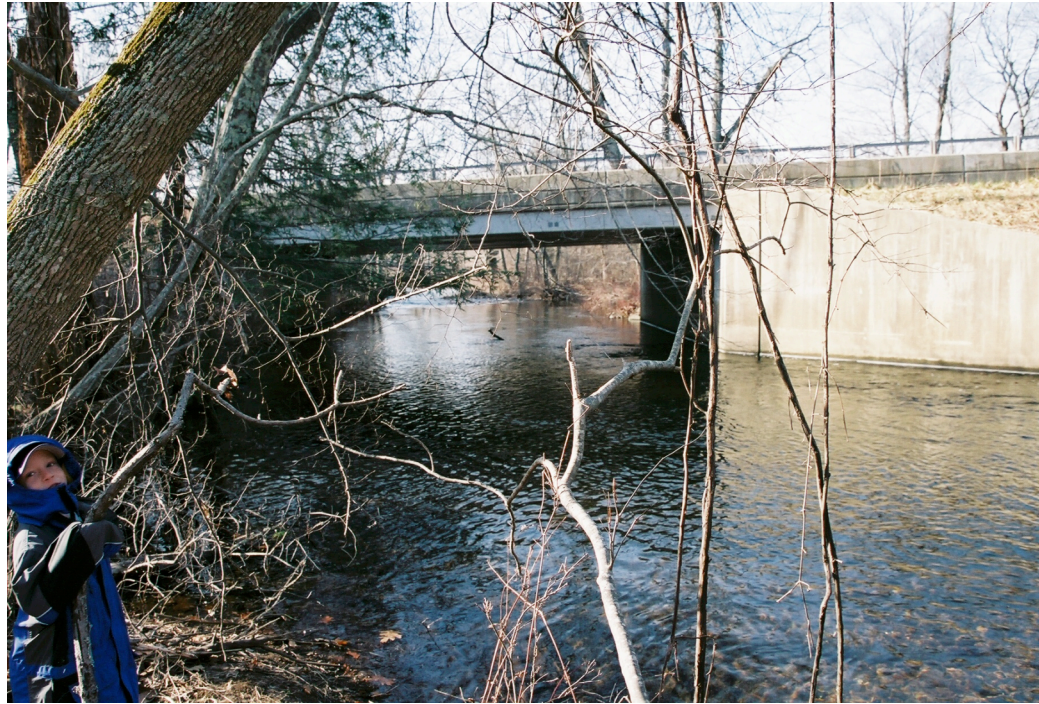
Figure 7. View downstream from Site 1

Downstream of the collection site is a concrete bridge constructed to support Route 156 over the Eightmile River (Figure 7). The stream bed under this bridge is composed of very fine sand sediment. It is remarkably barren of detritus and drift wood, very few animals were observed here.

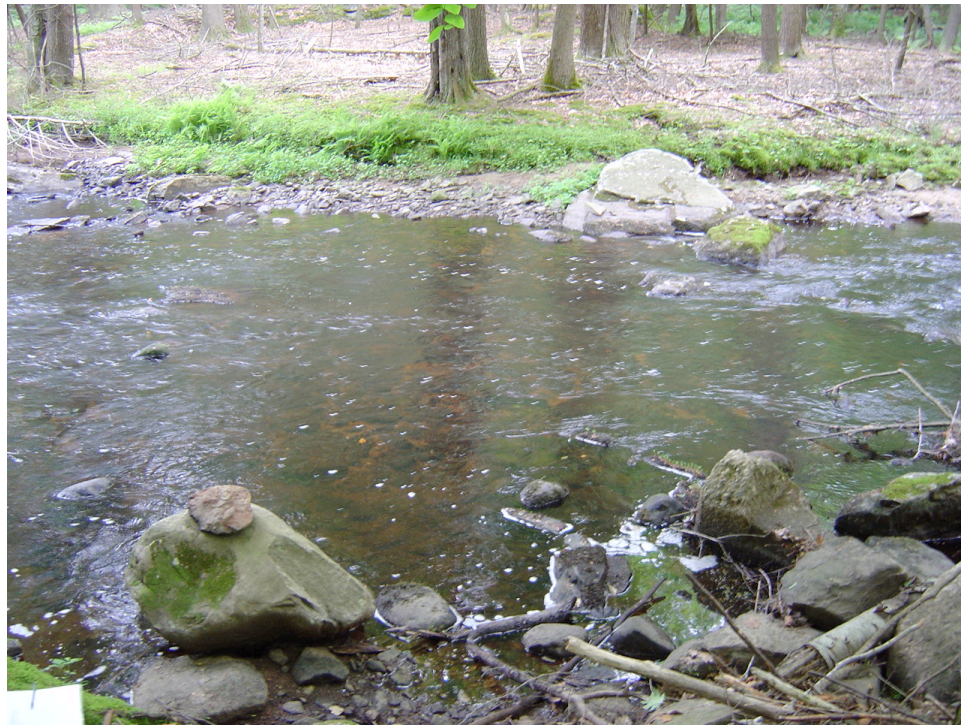
Figure 8. Site 2 collection location

Site 2 is also classified a fifth-order stream (Figure 8) (CT River Coastal Conservation District 2004). This site varied in depth and width based on the collection

The water at the Site 2 collection area is slightly turbulent due to the boulders. This creates pockets of still water. The water is clear and slightly tea colored.

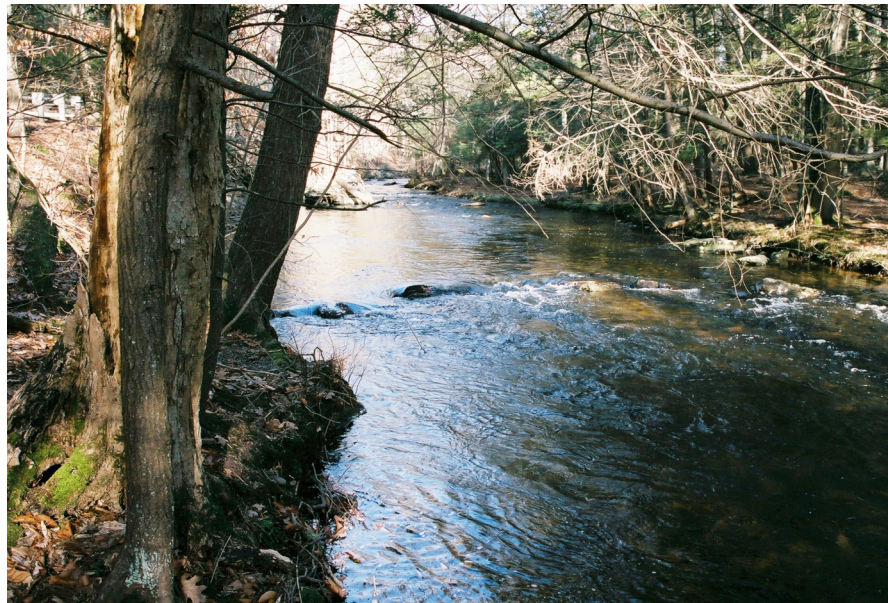
Figure 9. Upstream view from Site 2

date. It is also part of the West Branch of the Eightmile River and is located on Hopyard Road in East Haddam, Connecticut. The topography of this site is flatter than at Site 1, with a gentle slope up to Hopyard Road. Shading is present on the fringes of the river but a stretch of the center is open to sunlight year round. Many large boulders are present here with an abundance of detritus and drift wood. The stream sediments are darker in nature and seem to contain more silt than Site 1. The upstream (Figure 9) and downstream (Figure 10) conditions are similar to the collection site.

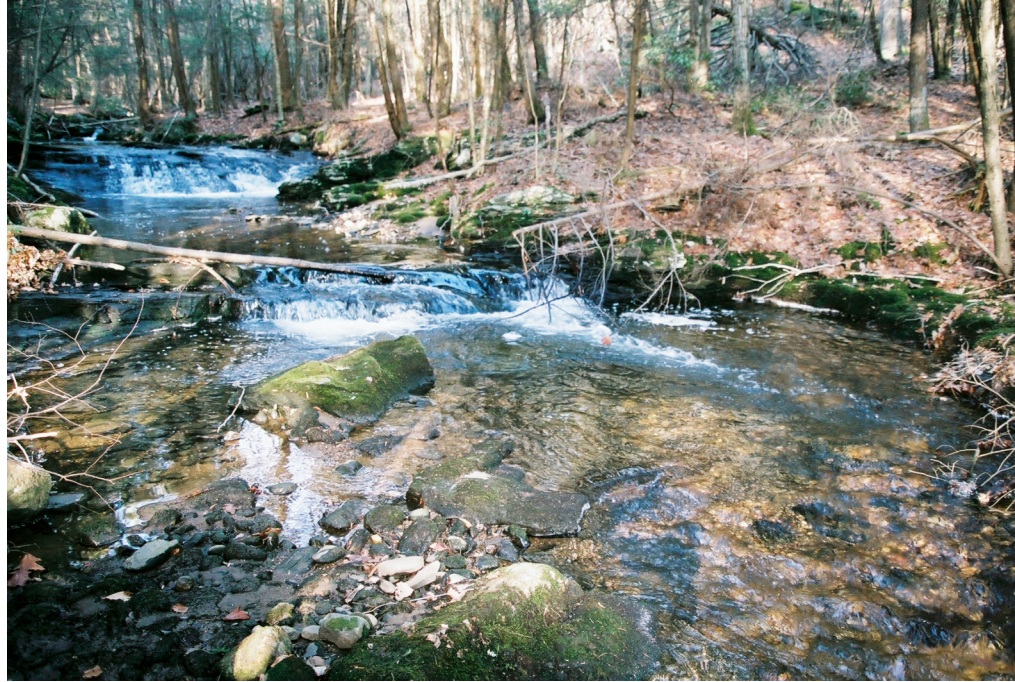
Figure 11. Site 3 collection site

Site 3, Muddy Brook is classified as a second-order stream (Figure 11) (CT River Coastal Conservation District 2004), a headwater stream under the River Continuum Concept, representing the transitional stretch in the river system (Vannote *et al.* 1980). Muddy Brook intersects the Eightmile River upstream of Site 2. The water appears consistently clear, with no color. The area is thickly forested resulting in heavy shading of the stream. Turbulence is high in the collection area due to the steep slope of the stream and the creation of the stream bed from bedrock. This results in a steep drop off forming a “mini” waterfall which empties into a small, very shallow pool.

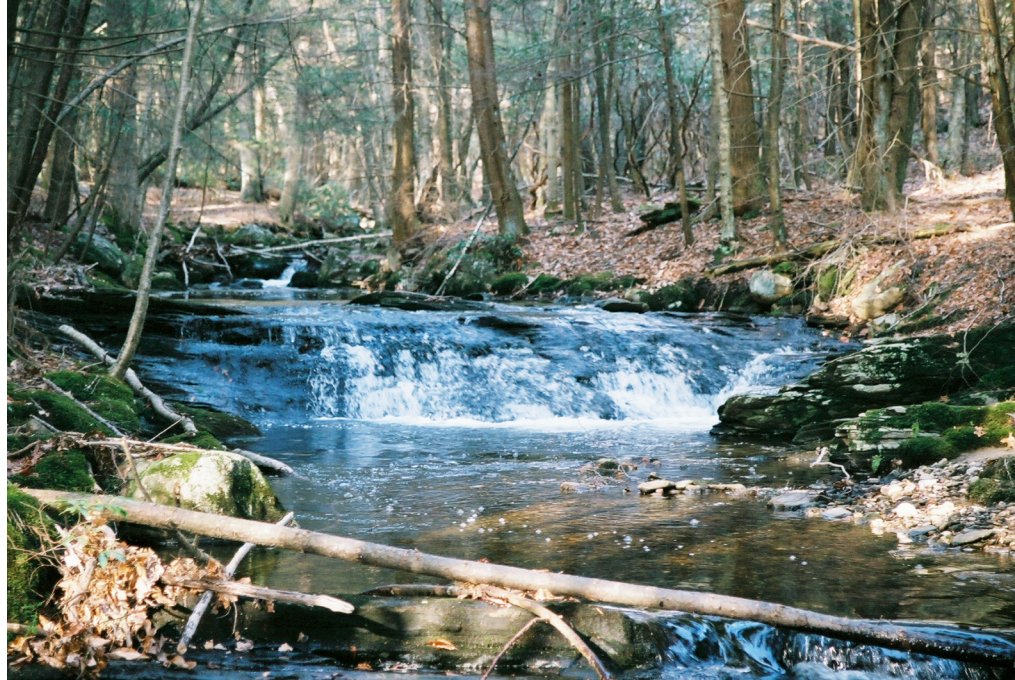
Figure 12. Upstream view from Site 3

This stretch of stream cuts through steep terrain in a crevice between two hills (Figure 12). Flow rate in this area varied; however, the depth and width of the stream did not vary due to the nature of the terrain. Sedimentation is very low in the stream. The bottom consists of mostly large, smooth, flat bedrock with pockets of detritus and fine sand. The terrestrial zone is extremely steep on both sides and is forested (Figure 13). Actual riparian area exists only when the water level is very low during the summer. The areas just lining the stream had an abundance of sphagnum moss, which is also present on areas of rock peeking above the surface of the water.

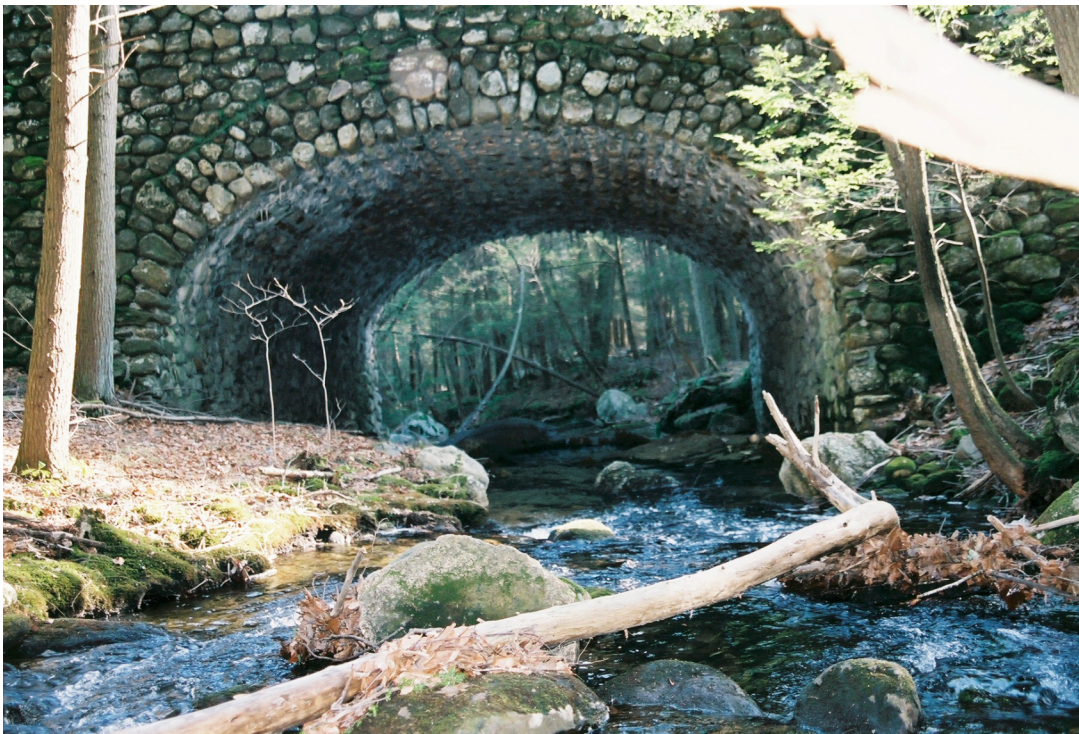
Figure 14. Stone bridge downstream of Site 3

Just downstream from the collection site is a stone bridge (Figure 14). Under the bridge is an abundance of fine sand with little to no detritus. White stalactites emerge from the spaces between the stones of the bridge. Just past the bridge, the pattern of steep, exposed bedrock and boulders, pocketed with pools of water, continues as the stream progresses downhill to the merge with the Eightmile River.

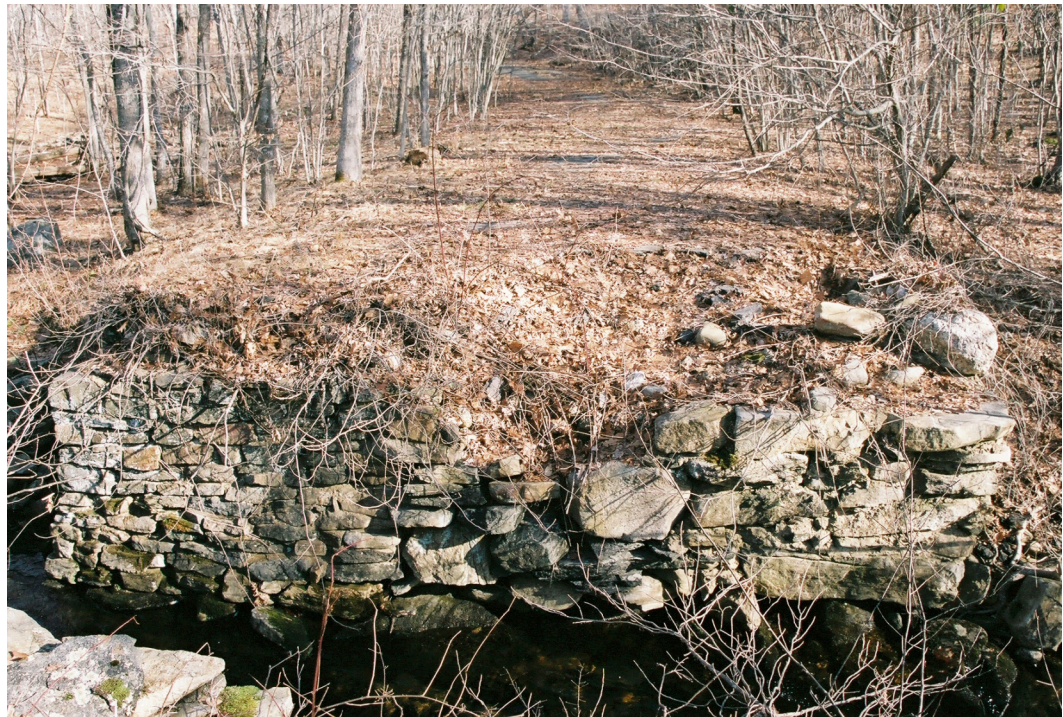
Figure 16. Bridge wall for road which is no longer in use near Site 4

Upstream there is a stone wall that was constructed to support a bridge for a road which is no longer in use. The function of this wall now is to hold back sediment which would otherwise impact the stream (Figure 16). Downstream both culverts pass under the road emptying into a wetland (Figure 17).

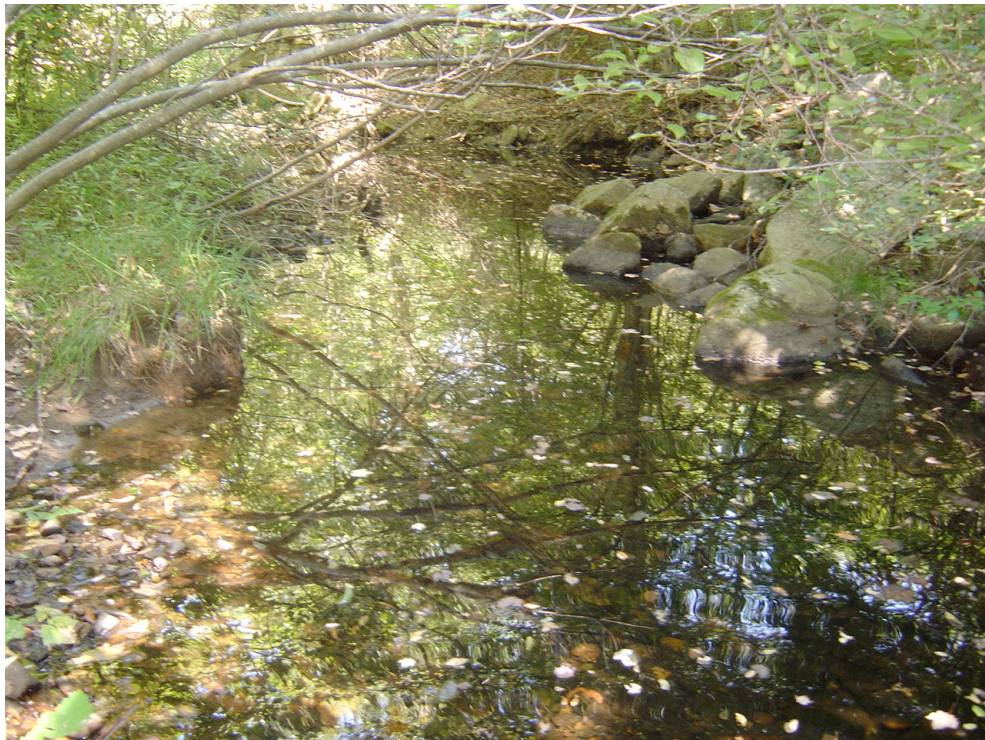
Figure 18. View of collection Site 5

Site 5, Early Brook, is classified as a second-order stream (CT River Coastal Conservation District 2004) (Figure 18). It also crosses Haywardville Road in East Haddam (Figure 19). This collection site is similar to Site 4 in that it is covered heavily with canopy and underbrush vegetation. This stream proceeds under Haywardville Road through one culvert which empties into the same wetland as Site 4.

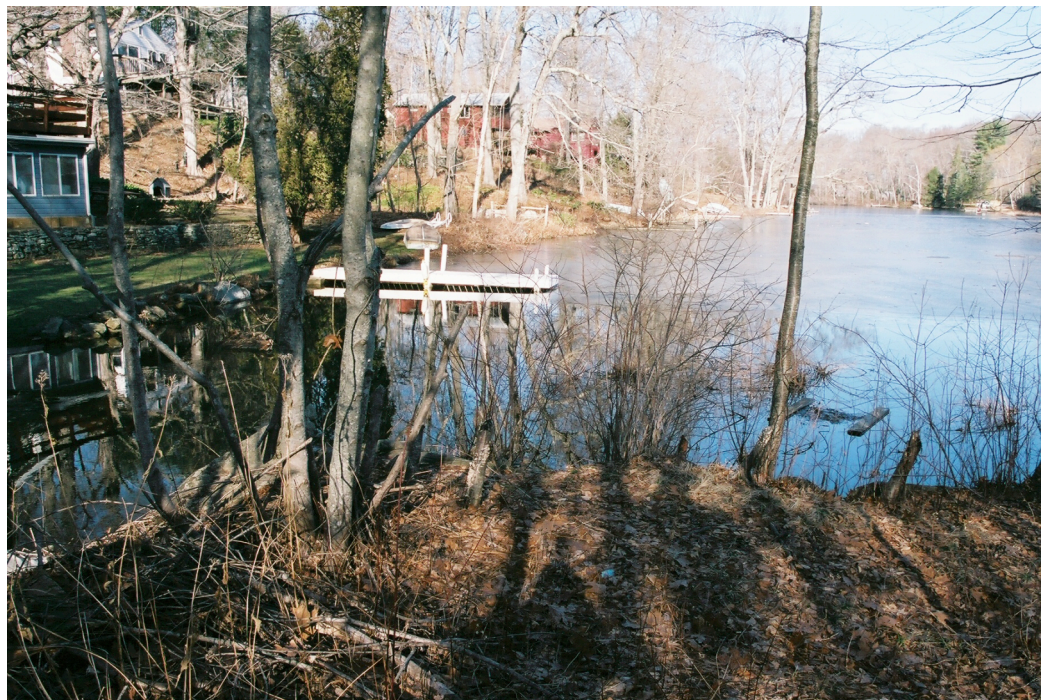
Figure 21. Lake Hayward were it empties through culverts above Site 6

Site 6 is Lake Hayward Brook at Mill Lane Road in East Haddam (Figure 20). This stream is classified as a third-order stream (CT River Coastal Conservation District 2004) and is fed from Lake Hayward (Figure 21). The major recharge to this lake is by three permanent and a number of seasonal streams (Norvell and Frink 1975). These streams run through a wetland into the lake. The lake and the wetland are divided by Lake Hayward Road which allows connection through culverts but frequently floods over the road. The topography of this area is very steep and vegetated within a buffer zone; however, the area within the lake's watershed has been heavily developed (Figure 22).

Site 6 measured the highest for turbidity and total suspended solids on all collection dates. This can be attributed to the location of the stream as it drains from Lake Hayward through a muddy area under Mill Lane then through culverts into Hayward Brook. The road debris, path of flow, and eroded sides of the stream bed could cause an increase in turbidity during times of precipitation and high runoff, as seen in October. Peaks in August are associated with limited flow and the low volume of water remaining for sampling.

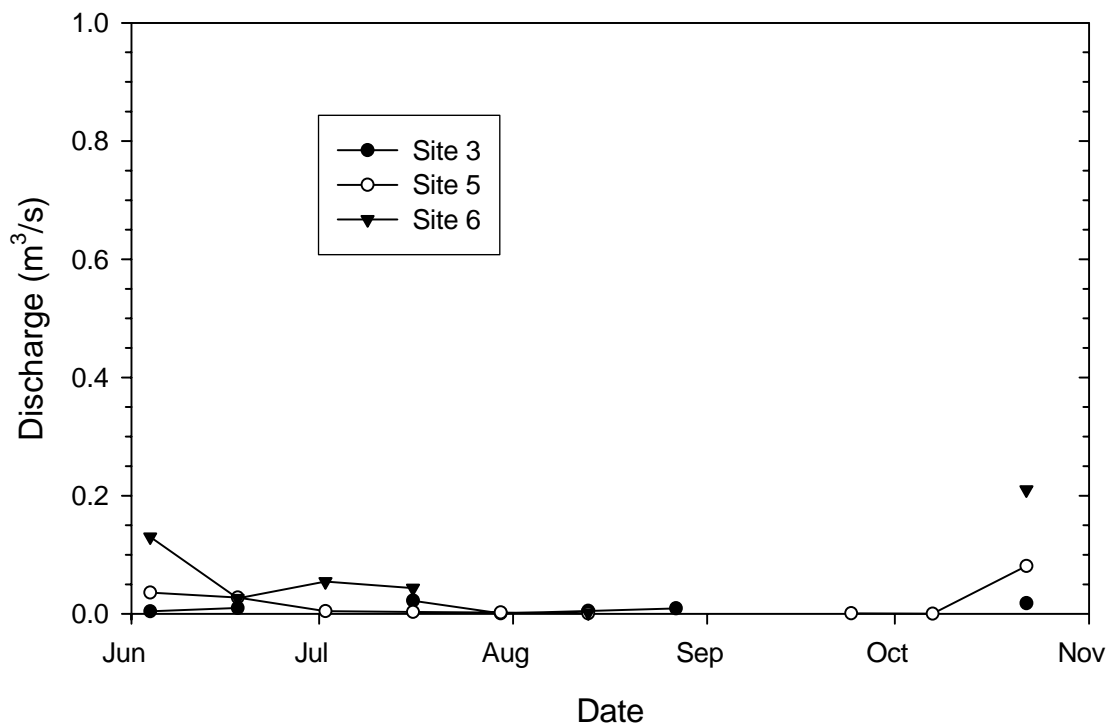
Figure 25. Discharge (m^3/s , mean \pm 1 SE) at Sites 1, 2, and 4, located on the West Branch mainstem of the Eightmile River, and Sites 3, 5, and 6, which are tributaries of the West Branch of the Eightmile River, for all collection dates during 2005.

The variability in flow for all sites can be attributed to temperature increasing the evaporation rate, relative humidity, precipitation, and amount of groundwater flow. Despite flow decreasing to undetectable levels at sites 3, 4, 5, and 6 for several collections (Appendices C and D), enough water was present to allow for discrete sampling.
